# **WATERSHED SURVEY FINAL REPORT & ACTION PLAN**

**LAKE WARNER / MILL RIVER WATERSHED  
AMHERST, HADLEY, LEVERETT, AND SHUTESBURY, MASSACHUSETTS  
FALL 2002 – WINTER 2003**

***Lake Warner /Mill River Watershed Study Group***  
***Fall 2002 Survey of Water Runoff***  
***Report Summary***

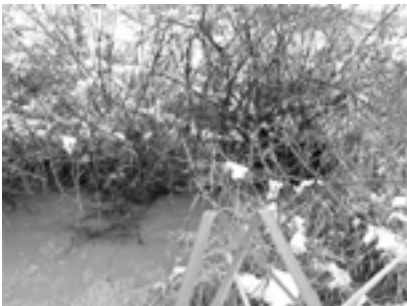
Perhaps the clearest example of direct flow of discolored water into the wetlands is evident near the south side culvert off the jogging track west of Alumni Stadium (photo #1 and #2).

2) Discolored water entering wetlands from culvert on the south side of the jogging trail west of Alumni Stadium.

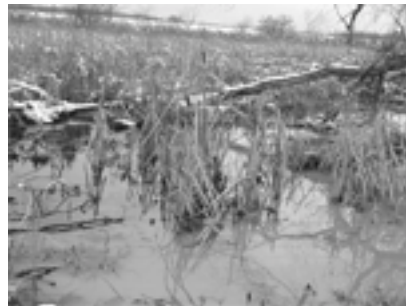
3) Murky water merges with clear water in streambed west of Alumni Stadium

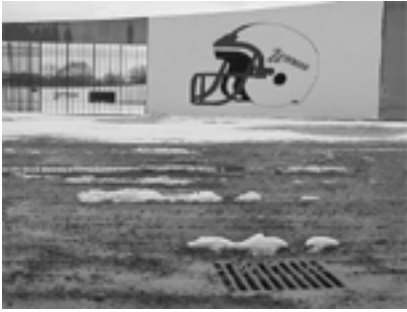
4) Source of discolored water discovered just south of Alumni Stadium where storm drain receives the runoff from a trap rock parking lot.

- Section 8 – Stop & Shop & CVS – Install BMPs that effectively buffer stormwater and allow proper infiltration.
- Section 11 - UMass Campus – Work to reduce impacts of runoff from unpaved parking lots south of the stadium

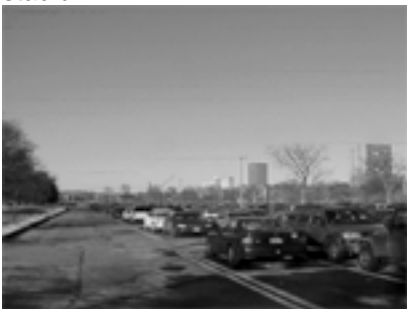
6 A) Parking lot just southwest of Southwest Towers (UMASS): Another potential problem area is the proximity of the dumpster and parking lot behind a fraternity on Pleasant Street, Amherst to the stream running from McClellan Street to just south of the visitor parking lot off Massachusetts Avenue.

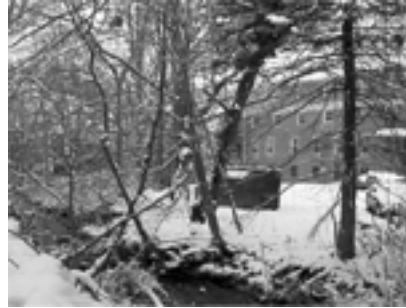
11) Just north of this site is another area of concern where a storage shed rests right on the lip of the stream. This site was accessed from Lincoln Street (where the married student housing once was). Go around back. When you arrive, you will be at the rear of 85 Fearing Street.

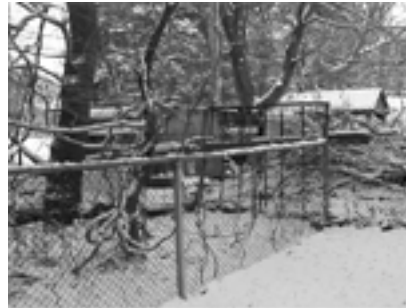
11) Rear of 85 Fearing Street property.

These trees have fallen into the stream between Fearing Street and Pleasant Street offering squirrels an excellent opportunity to cross the waterway.

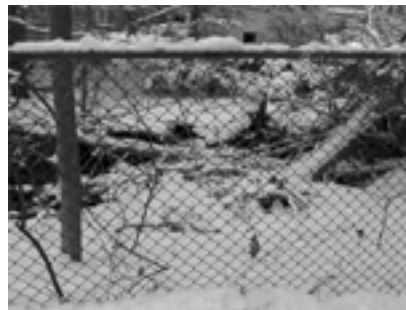
9A) Either soil caves into the stream on the north side of Massachusetts Ave. just east of the intersection of Mass Ave. and Mullins Way or the snow has covered a concrete culvert ( something to check out at another time).

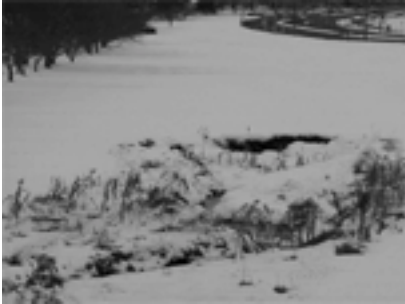
9) Keep an eye on the culvert under Mullins Way where rock used in rip rap has collected in the bottom of the culvert.

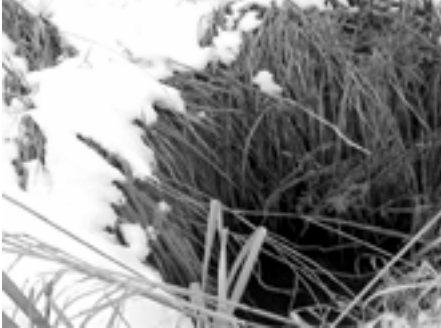
13) Finally, keeping an eye on the overgrowth of culvert #1, just off Rocky Hill Road may be a good idea since the grasses have overgrown the culvert and threaten to impede the flow.
